## Bacterial Dosing Case Study: South Taranaki Dairy Farm

### Background Information

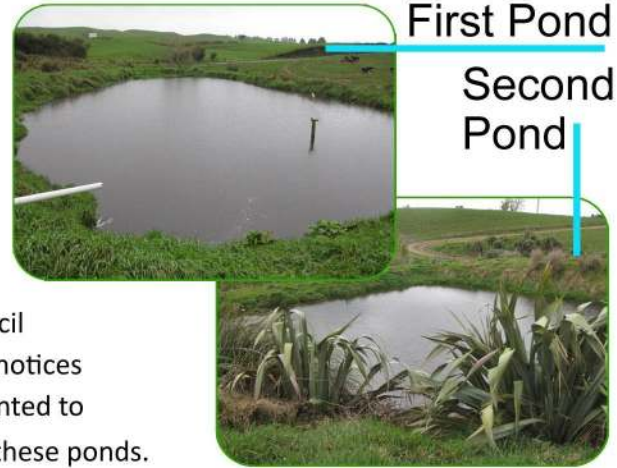
Sept. 9th

**September 9th** - First pond shows the sludge being slowly lifted to the top of the pond.

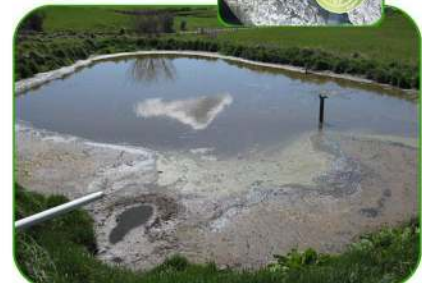
Nov. 30th

**November 30th** - Samples tested. First pond shows an increasing level of sludge being lifted from the bottom of the first pond as well as much more biological action (small pieces of sludge being lifted and bubbling).

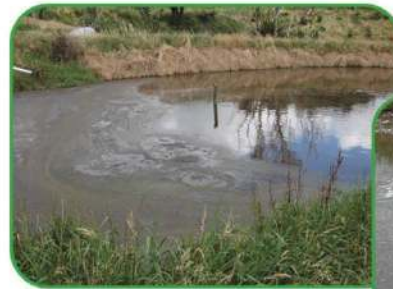
Feb. 13th

**February 13th** - Samples tested. A huge increase in biological action taking place. Vast increase in amount of sludge rising.

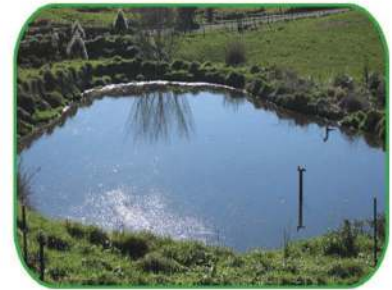
July 2nd

**July 2nd** - Samples tested. Samples looking much clearer. Analysis shows sludge has gone through the system from the highs of May and now the owner can maintain the pond well under his discharge consent limits.

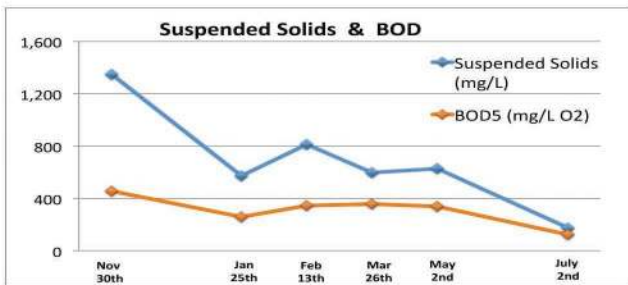
## Pond 1 - Analysis

All graphs shown are from analysis conducted by an independent IANZ accredited test lab except Sept 28th which are from the South Taranaki Regional Council.

As the above results clearly show, Ecogreen BioTab's have been tremendously effective in accelerating waste remediation at this site and, in turn, increased the holding capacity and retention time in the ponds by reducing sludge levels. The owner can now easily maintain a clean and effective pond system that will allow him to stay well under his consent limits.
